SCRATCHING THE SURFACE PROJECT (2017)
INVESTIGATION AND PLANNING OF A CONCEPT FOR MAINTENANCE OF
A STREET ART MURAL BY VHILS AT THE EMBASSY OF PORTUGAL,
BANGKOK, THAILAND

An Independent Study Submitted in Partial Fulfillment of the Requirements
for Master of Arts CULTURAL HERITAGE CONSERVATION AND
MANAGEMENT

Silpakorn University
Academic Year 2023

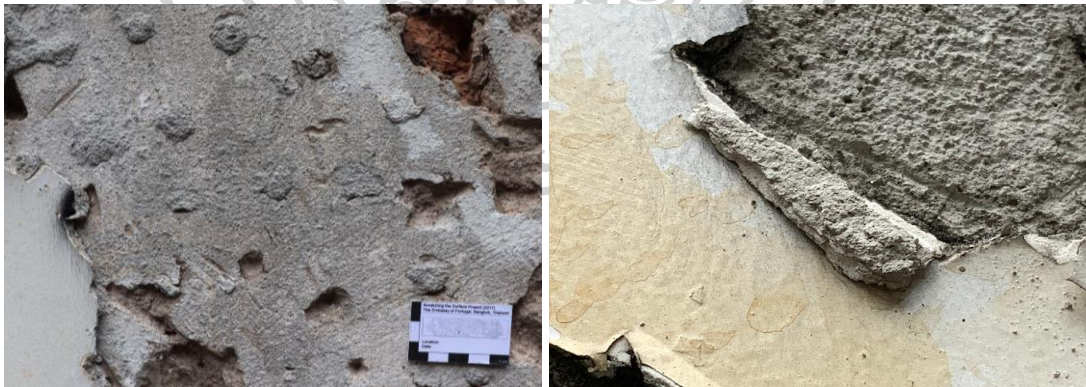
There are traces of keying of the plaster by mechanically roughening the surface to improve adhesion to prepare the surface for the next layer of plaster.⁴³ Figure 46 shows a newer layer of plaster from a past renovation that has been embossed from an old keying of the plaster hole. Even though the newer layer has been chipped off, traces of the new plaster layer can still be found in the holes. All of these are the original plasters that have been applied over many layers in the past, prior to the creation of the artwork by VHILS.

Figure 46 Traces of keying the plaster
Source: Khakhanang Jonganurak (June 12, 2023)

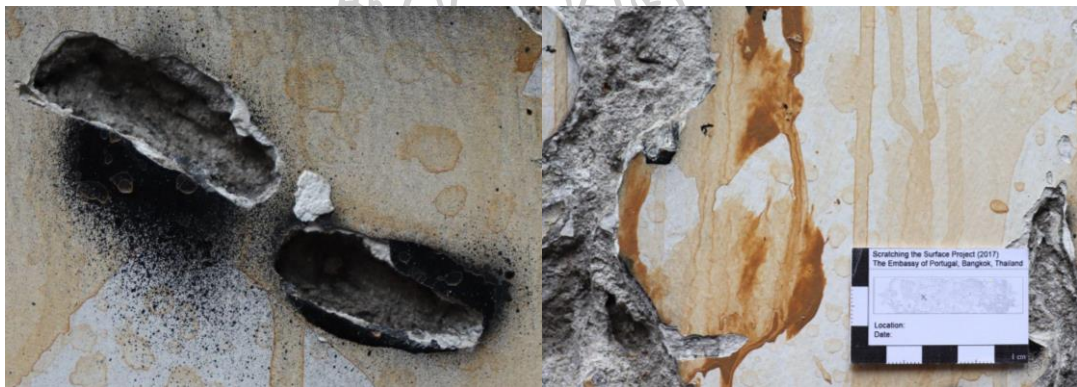
Figure 52 Traces of the aerosol dispersion of the black spray paint
Source: Elias Campidell (June 12, 2023)

Figure 53 The uneven brown dripping stains
Source: Elias Campidell (June 12, 2023)

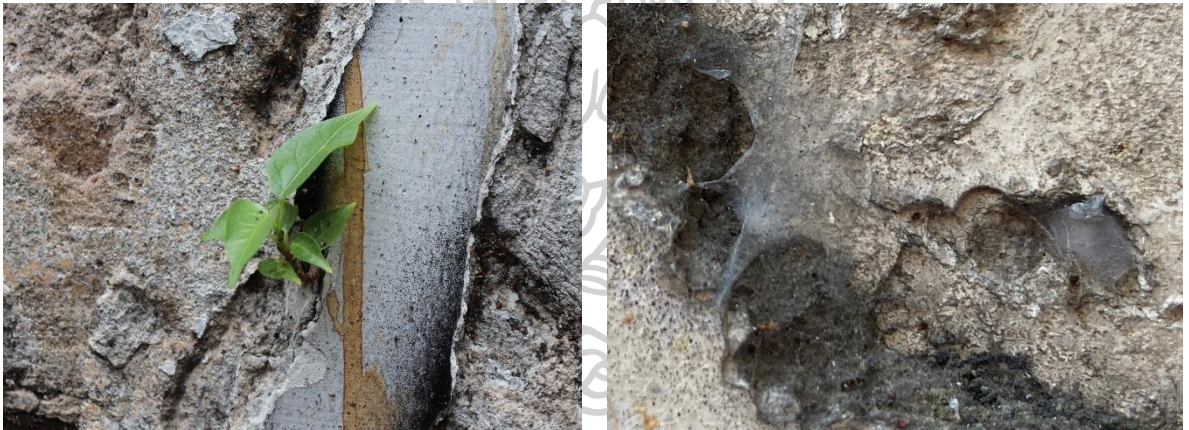
Figure 61 The growth of plants in the wall's crevices
Source: Elias Campidell (June 12, 2023)

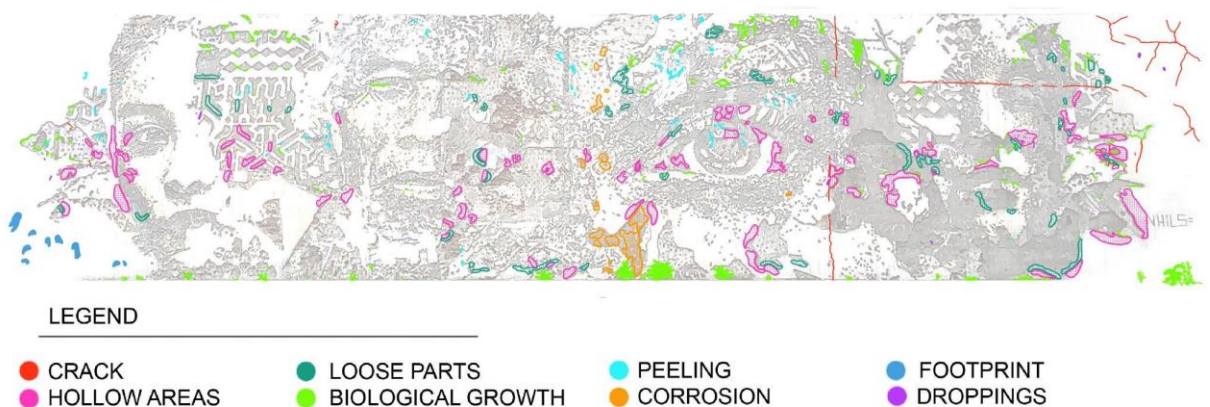
Figure 63 Condition mapping
Source: Khakhanang Jonganurak (June 15, 2023)

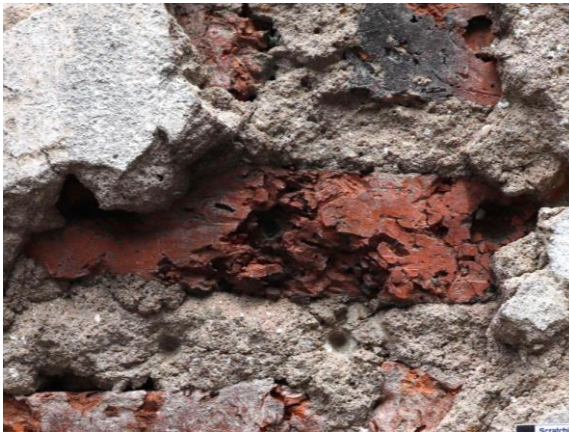
Figure 64 Cracking and crumbling brick
Source: Khakhanang Jonganurak (June 12, 2023)

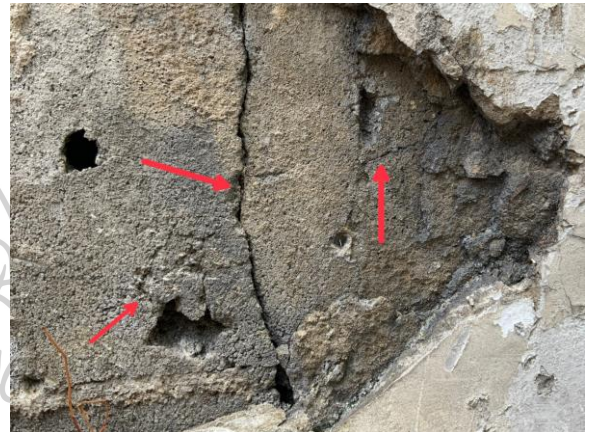
Figure 65 Cracking concrete block
Source: Khakhanang Jonganurak (June 12, 2023)

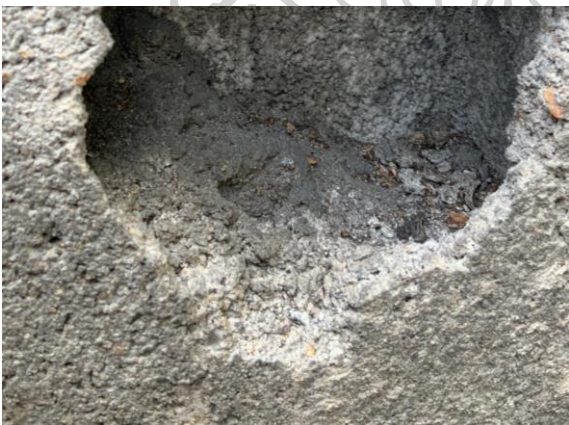
Figure 66 Dust and dirt accumulate in the hollow space of the concrete block
Source: Khakhanang Jonganurak (June 12, 2023)

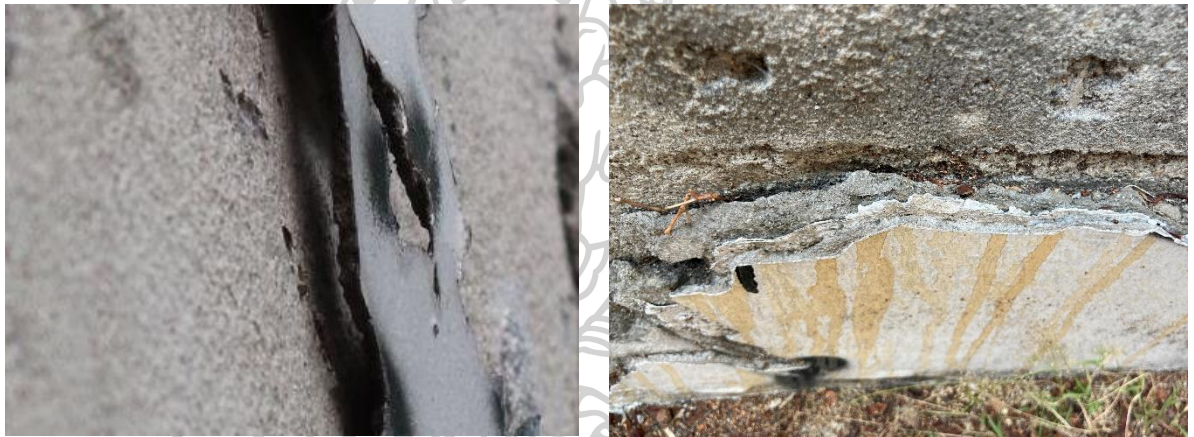
Figure 68 The loose part between the plaster layers
Source: Elias Campidell (June 12, 2023)

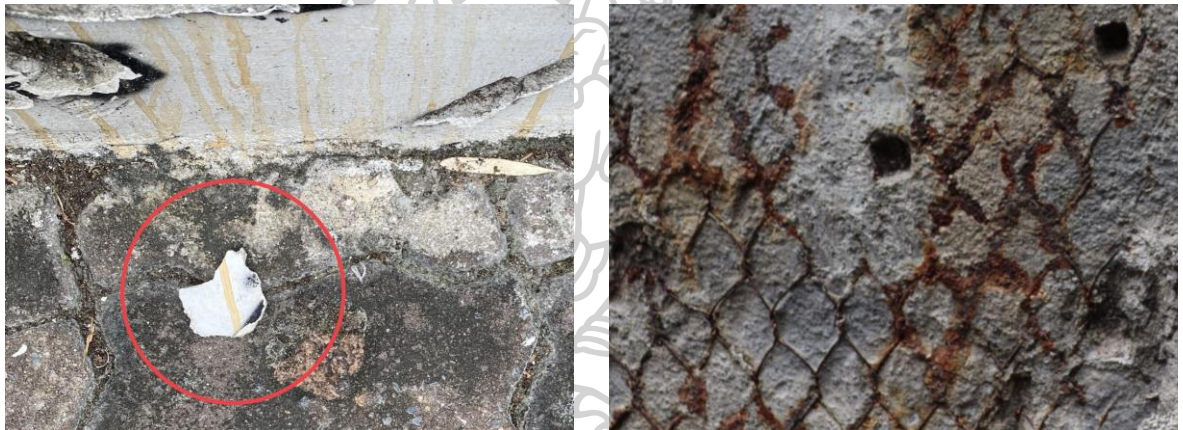
Figure 70 A fragments of the wall's plaster on the floor
Source: Kawinthip Kittiphong (June 26, 2023)

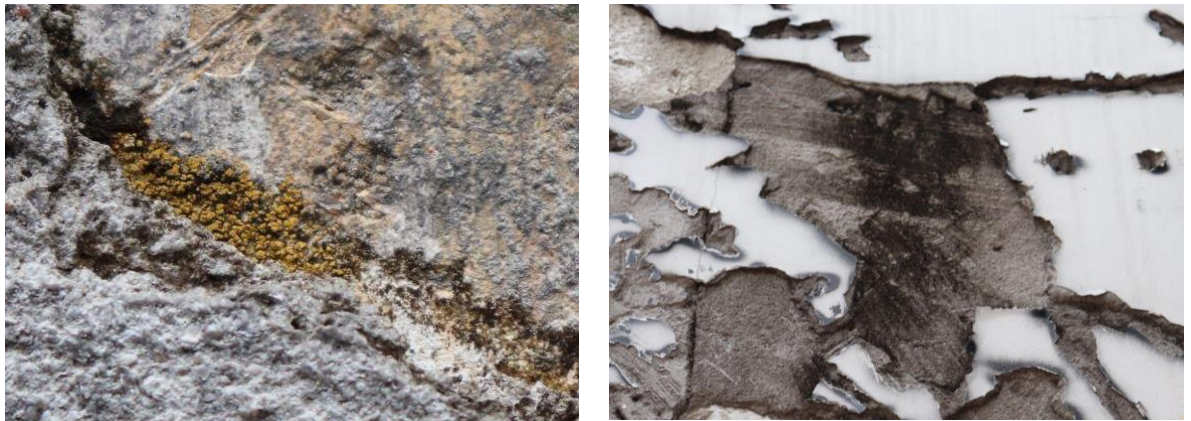
Figure 72 Biological colonisation with a yellowish green appearance
Source: Elias Campidell (June 12, 2023)

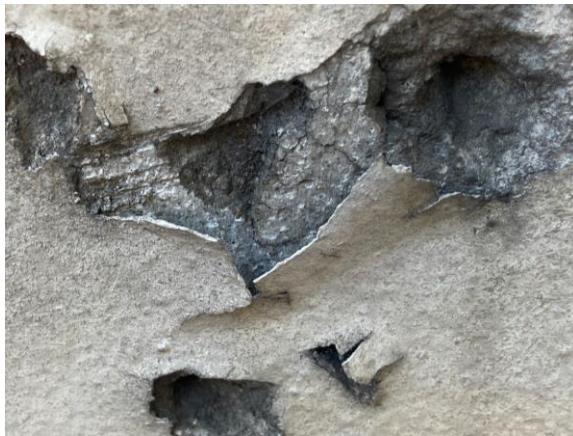
Figure 75 Peeling of paint layer
Source: Khakhanang Jonganurak (June 12, 2023)

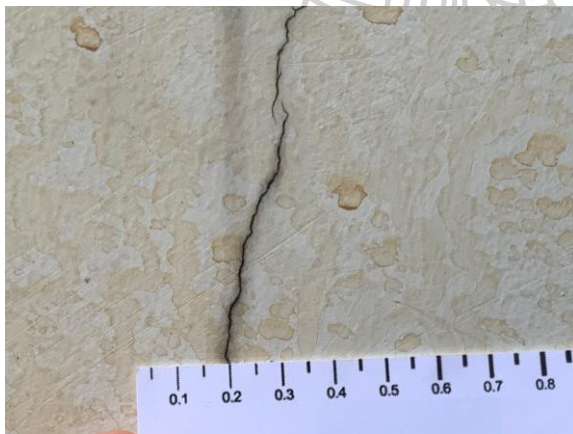
Figure 77 Cracking of the paint layer
Source: Khakhanang Jonganurak (June 12, 2023)

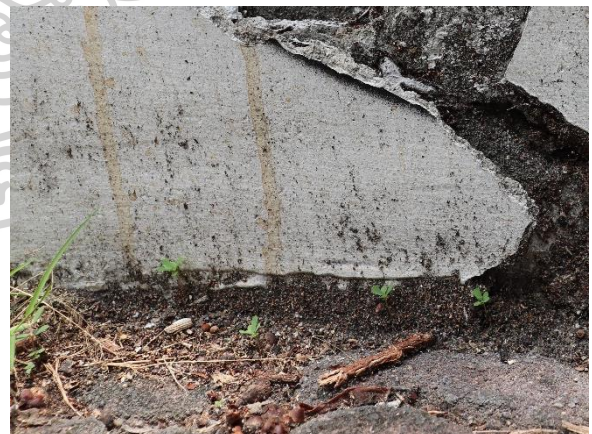
Figure 78 Black stain of dirt and dirt on the lower part of the wall
Source: Khakhanang Jonganurak (June 12, 2023)

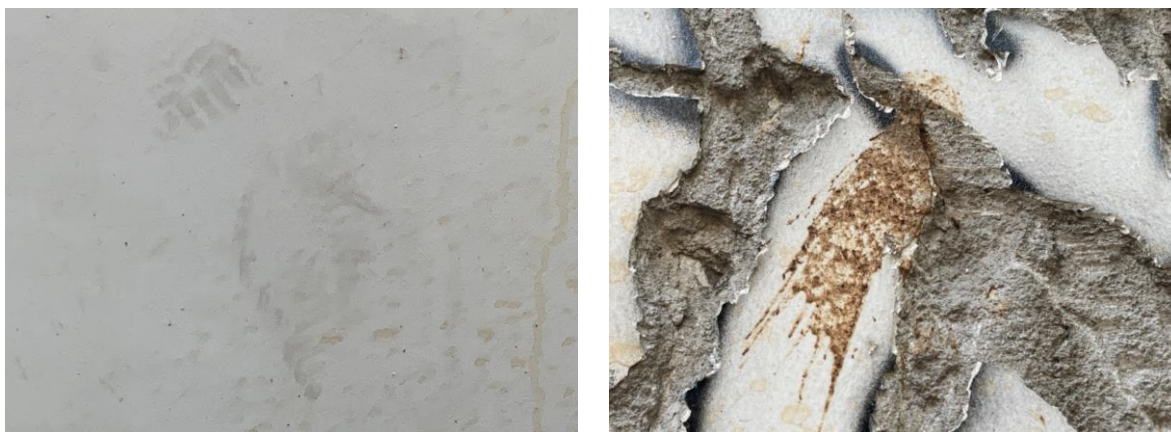
Figure 79 Footprints in the lower left corner of the artwork
Source: Khakhanang Jonganurak (June 12, 2023)
