SCRATCHING THE SURFACE PROJECT (2017)
INVESTIGATION AND PLANNING OF A CONCEPT FOR MAINTENANCE OF
A STREET ART MURAL BY VHILS AT THE EMBASSY OF PORTUGAL,
BANGKOK, THAILAND

An Independent Study Submitted in Partial Fulfillment of the Requirements
for Master of Arts CULTURAL HERITAGE CONSERVATION AND
MANAGEMENT

Silpakorn University
Academic Year 2023

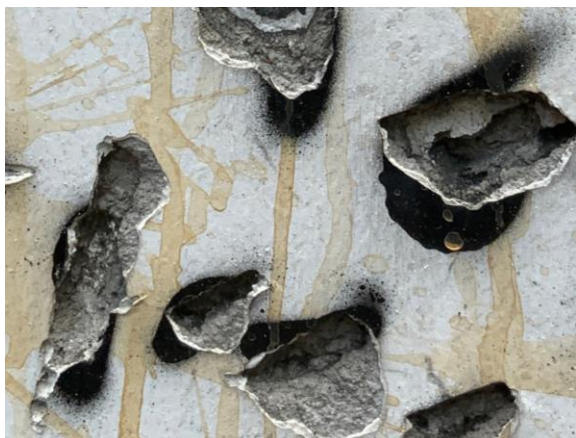
Figure 6 Black spray paint around the edges of the pattern

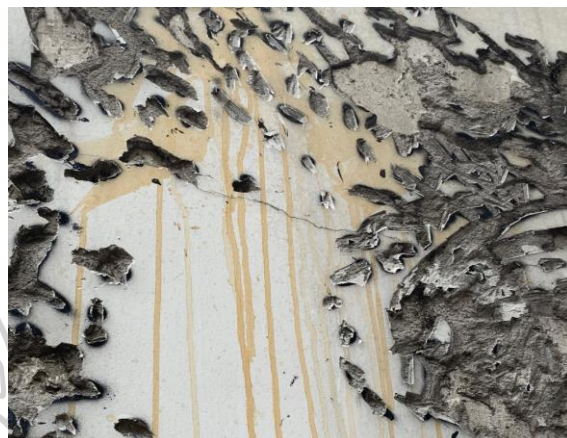
Figure 7 Fluid brown stain on the wall

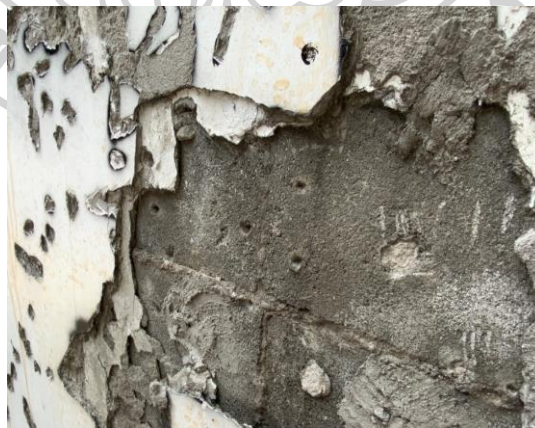
Figure 14 Layers of the wall at the artwork area

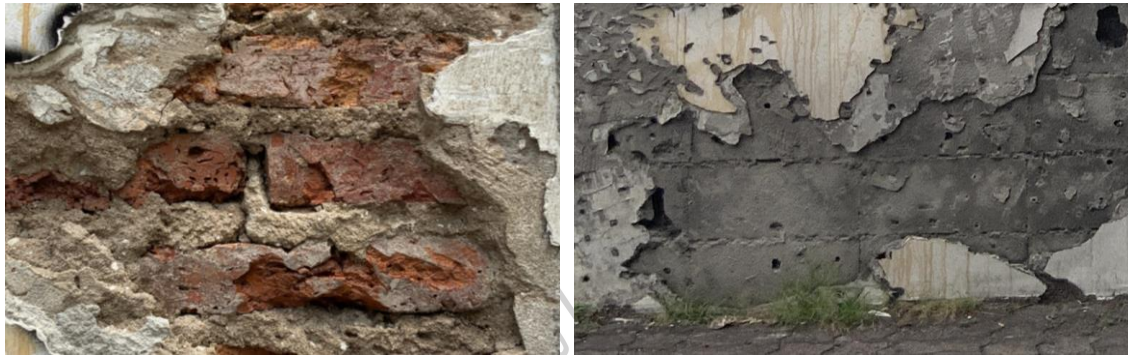
Based on optical observation, the masonry layer beneath the artwork contains two types of materials: bricks (figure 30) and concrete blocks (figure 31). The wall's structure includes columns, which provide vertical support for the wall's stability and strength. They act as a sub-support for each small section of the wall. In Figure 32, the artwork on the wall is divided into small sections. Red markers indicate the location of vertical support columns that are inserted between the sections. These columns are represented by using the letters K to U, which help in referencing

Figure 30 Brick masonry wall
Source: Khakhanang Jonganurak (December 1, 2022)

Figure 31 Concrete masonry wall
Source: Khakhanang Jonganurak (December 1, 2022)

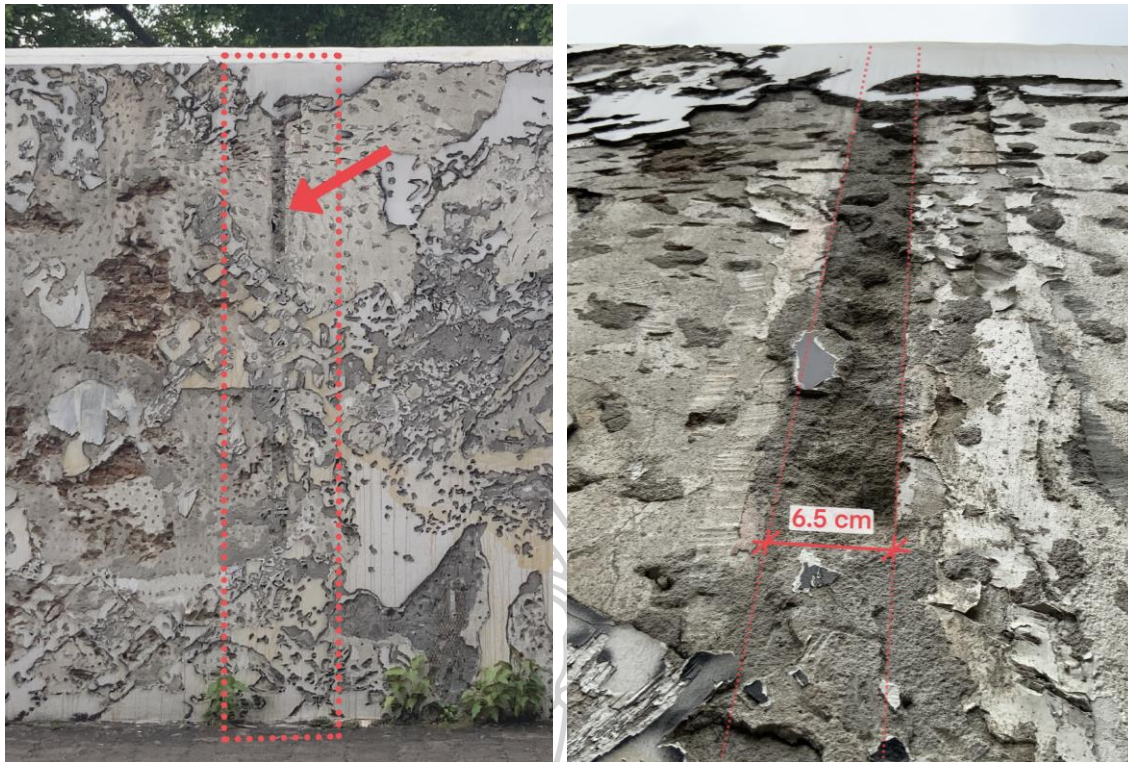
specific areas within the artwork. The distance between each column, from centre to centre, is approximately 1.56 m, and the columns are 6 - 6.5 cm thick. The columns are most visible in the plaster layer. They have a darker grey colour than the rest of the wall plaster, and some parts show small vertical cracks along the column line (figures 33 - 34).

Figure 33 The position of a vertical support column in the wall
Source: Khakhanang Jonganurak (August 9, 2023)

Figure 34 Close up picture of the vertical support column
Source: Khakhanang Jonganurak (August 9, 2023)

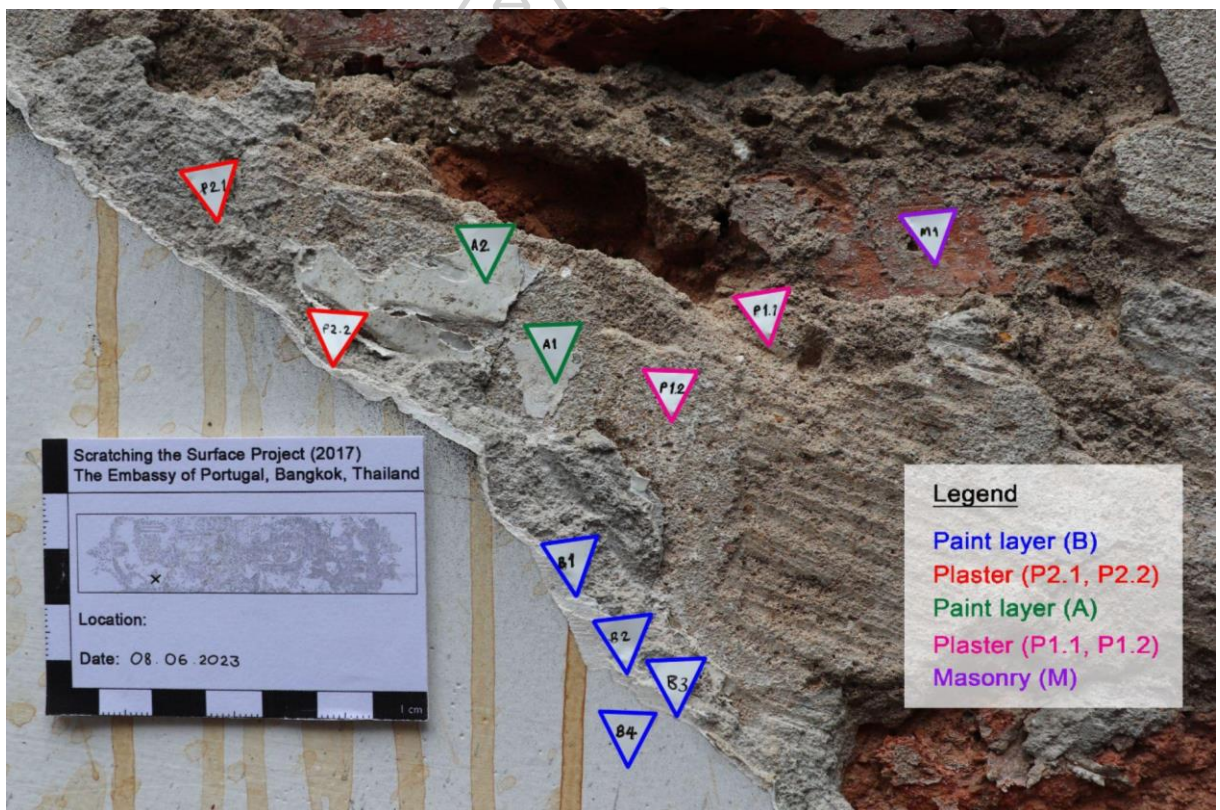
Numbering of Layers: Location I - Figure 41, the first plaster layer on the brick masonry wall is marked as P1.1. It is about 1-1.5 cm thick and has a matte surface with a slightly yellowish colour. Some small pebbles and sand can be seen mixed in the plaster. There are also white grains about 0.1-0.5 cm in size, which are assumed to be lime lumps. Lime lumps occur when quicklime isn't properly mixed with water and sand. It is basically inclusions of quicklime.⁴² Because of this finding we can assume that the binding media of this layer is lime. The next plaster layer (P1.2) is like the first plaster layer (P1.1) but thinner, with a layer thickness of less than 0.5 cm. After the two plaster layers, there are two paint layers (A1, A2). On top of them another plaster layer follows (P2.1). It has a greyish colour and a slightly shiny texture compared to P1.1 and P1.2. The last plaster (P2.2) is the layer beneath the top paint layers (B1-B4). It has a finer grain and a thinner surface than other plaster layers.

Figure 41 The numbering of Layers: Location I
Source: Khakhanang Jonganurak (June 15, 2023)

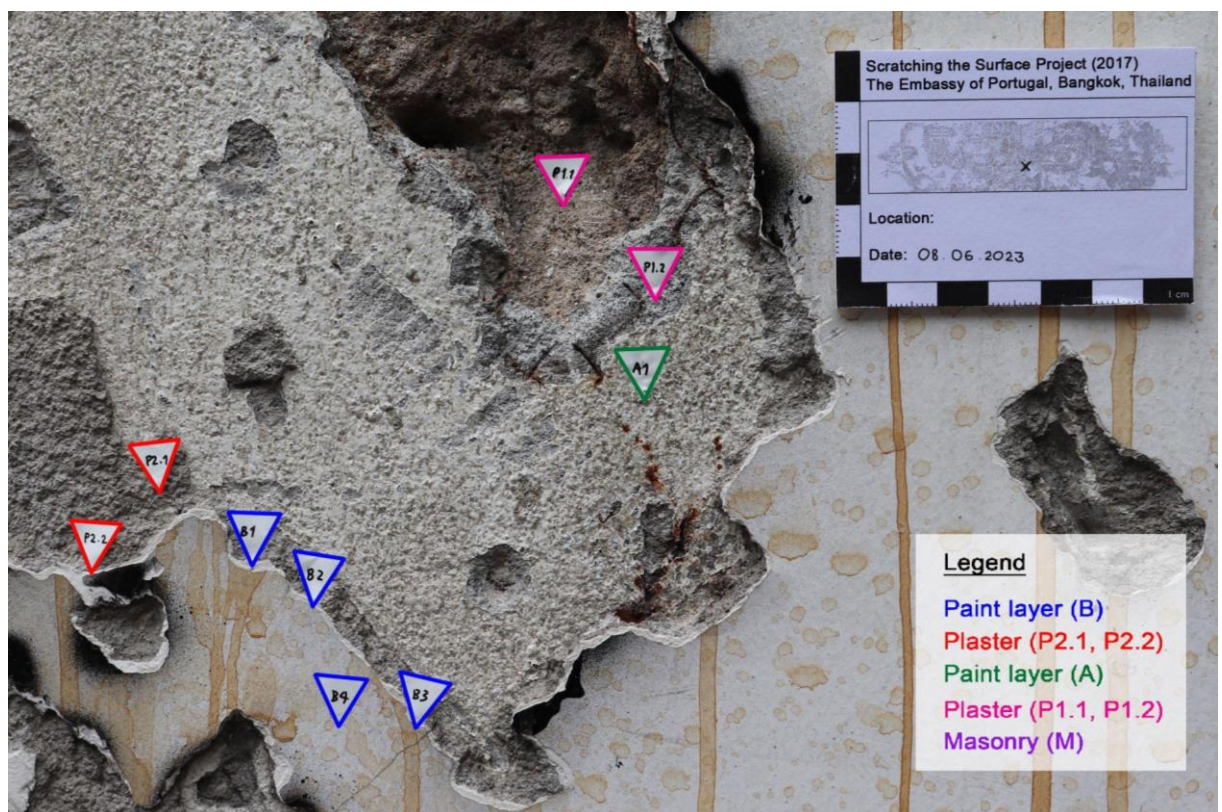
Numbering of Layers: Location II - Figure 42, the first plaster layer (P1.1) is on a brick masonry. It has a similar overall appearance to the first plaster layer from 'Numbering of Layers: Location I'. Next plaster layer (P1.2) has a thickness of about 1-1.5 cm, with a metal mesh inserted in the plaster layer for reinforcement. The metal mesh can be found in a small area of the wall (P-Q) (Fig. x). Next comes the plaster layer P2.1 on top of the A1 paint layer, which has a rough texture, grey colour, and about 0.3 cm thickness. After that, it follows P2.2, which looks like P2.1 but with slightly finer texture.

Figure 42 The numbering of Layers: Location II
Source: Khakhanang Jonganurak (June 15, 2023)

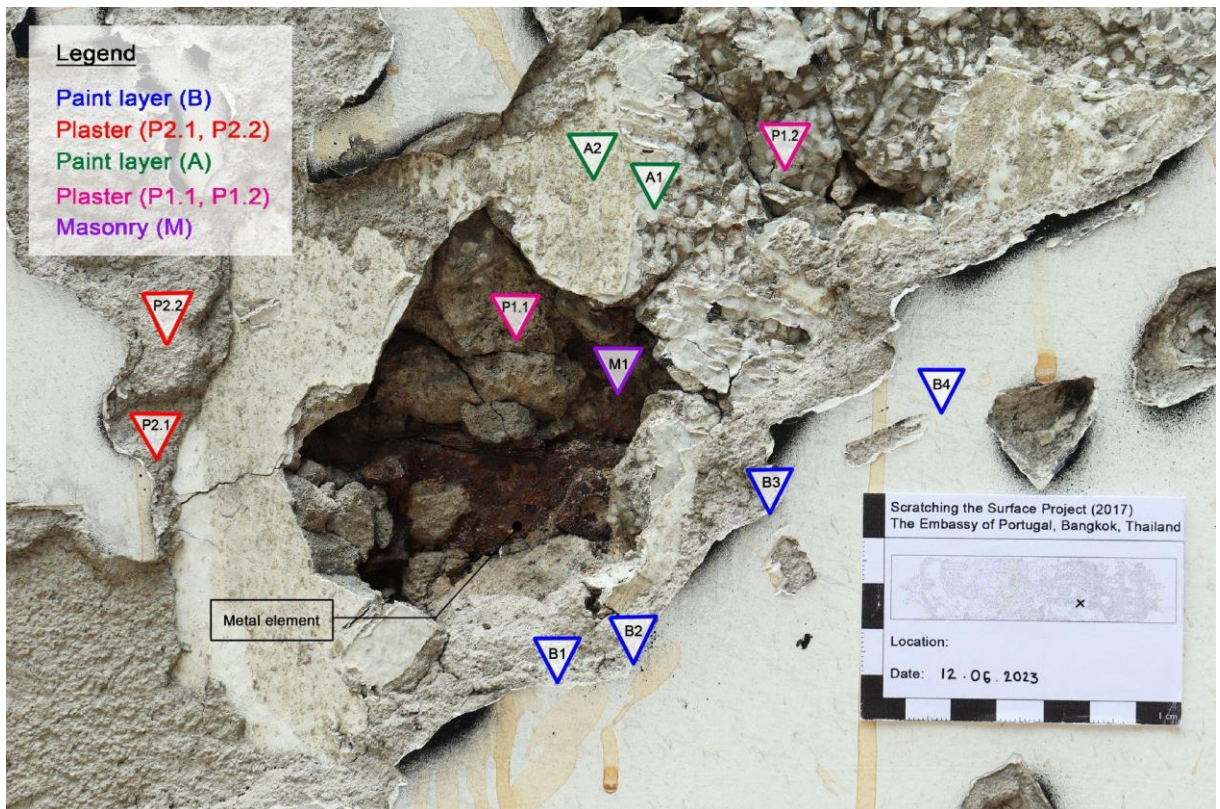
Numbering of Layers: Location III - Figure 43, in this location, the first plaster layer is still on the brick wall and looks similar to the first plaster layer from 'Numbering of Layers: Location I'. In location III, a metal plate and nut were found attached to the wall at one point, the purpose of which is still unknown. The next layer (P1.2) is a pebble wash plaster that is about 1 cm thick and has a rough texture. It is a grey plaster and consists of coarse-grained material, which is mostly white rock with a diameter of about 0.3 cm. After the paint layer (A), two plaster layers (P2.1 - P2.2) follow. They are about 0.2 - 0.3 cm thick. It has a coarse grey texture with small grains with diameters ranging from 0.1-0.15 cm.

Figure 43 The numbering of Layers: Location III
Source: Khakhanang Jonganurak (June 15, 2023)

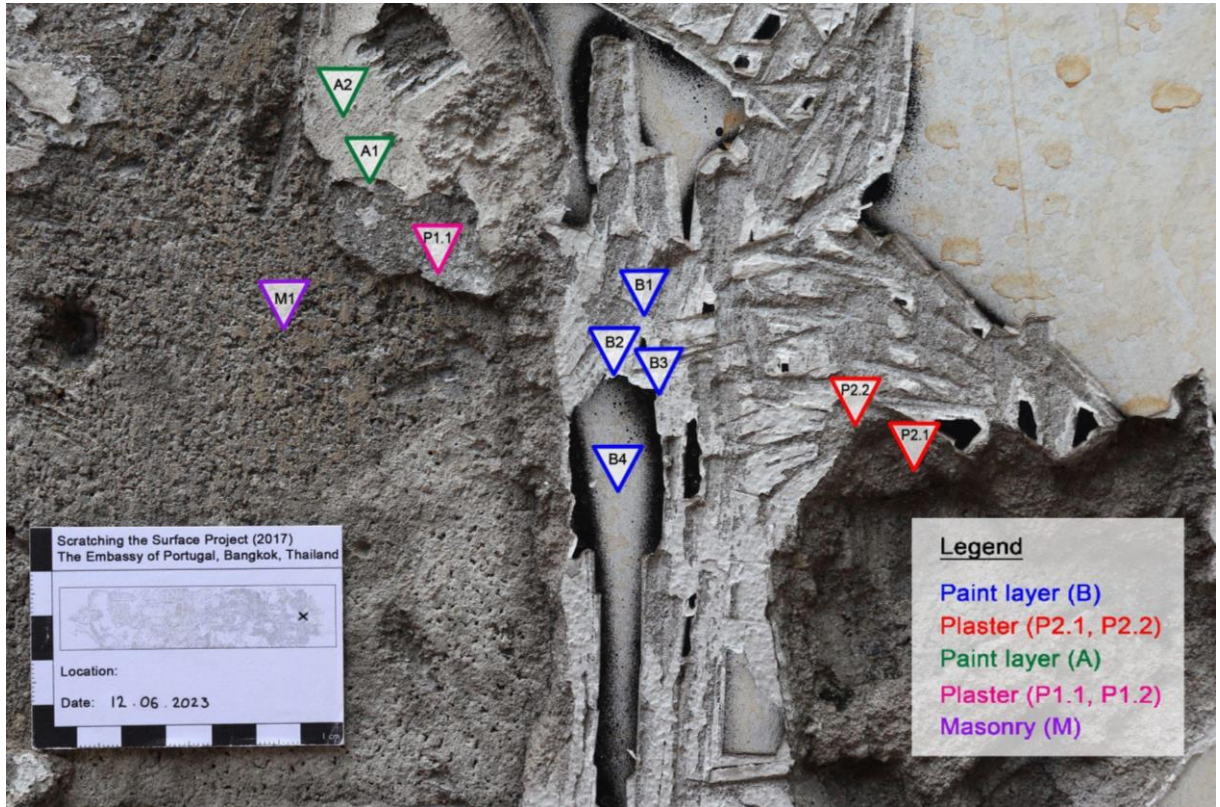
Numbering of Layers: Location IV - Figure 44, the first plaster layer (P1.1) is on the concrete block wall. It has a grey colour and is less than 0.5 cm thick. On top of this plaster, two paint layers (A1 and A2) follow. Next, another two plaster layers follow (P2.1 and P2.2). Their thickness is approximately 0.3 cm, and their colour is grey with a mixture of small grains.

Figure 44 The numbering of Layers: Location IV
Source: Khakhanang Jonganurak (June 15, 2023)

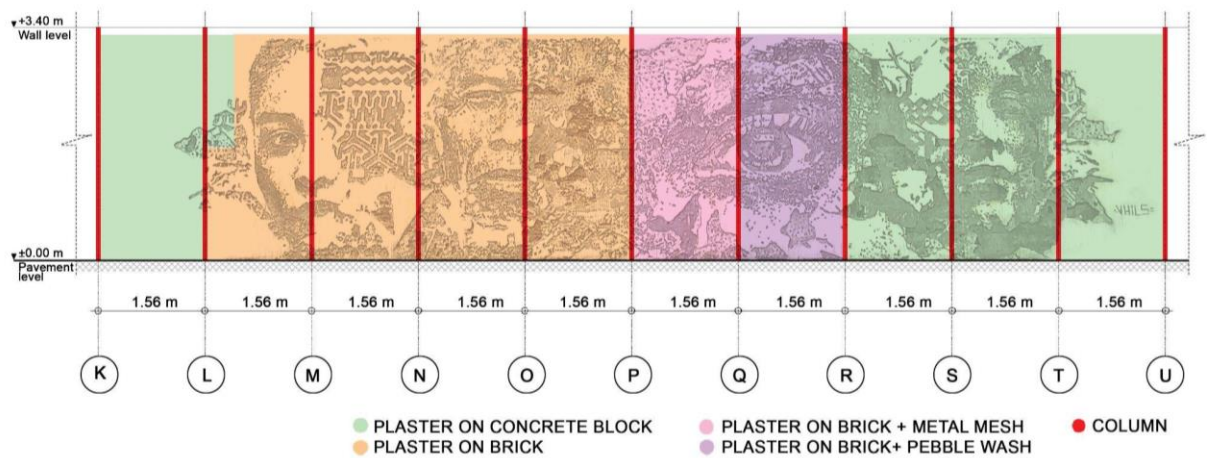
Figure 45 The diagram of plaster on masonry wall that divided into a small section by the column
Source: Khakhanang Jonganurak (June 15, 2023)

Figure 45 depicts the location of the various types of plaster layers discovered on the wall beneath the street artwork in various colours. The plaster on the concrete block masonry is represented by the green area. The orange area is plaster applied over brick masonry. The pink area is plaster with metal mesh over brick masonry. The plaster and pebble wash on brick masonry is the final type in the purple area.

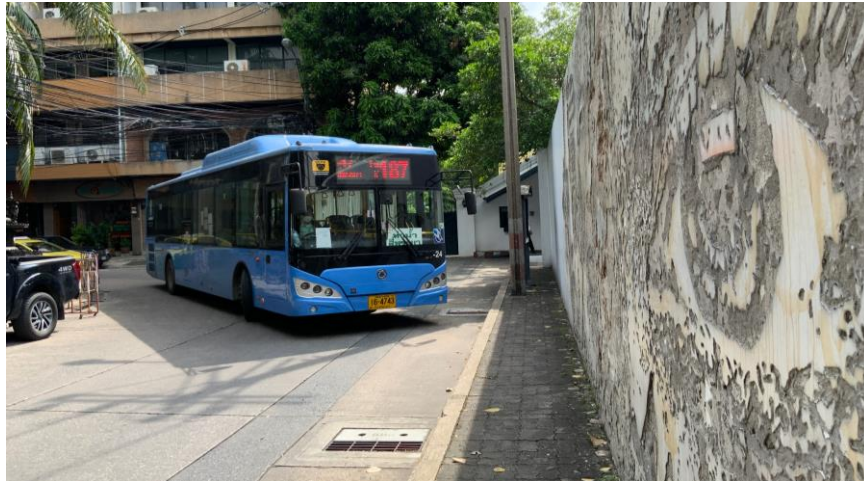
The vehicles cause road vibrations, which is a common problem caused by large vehicles such as public buses and heavy tour buses. Another factor is the texture of the road surface. Very rough surfaces produce more vibration than smooth surfaces, generating dynamic loads on the road and becoming stress waves that travel down into the soil, which can carry vibrations to the foundation of the wall. When a large vehicle traverses an uneven road, it exerts a forceful impact on the ground, generating a load that results in oscillating vibrations. Traffic vibration can result in cracks in walls or foundations where it accumulates in the wall structure (multiple times), causing fatigue damage. However, the vibration from vehicles is not strong enough to

cause major damage to the wall. But it creates cumulatively minor damages connected with other existing problems like structural problems in the wall caused by previous repairs, soil subsidence, humidity, and temperature.⁴⁷

Figure 56 The turns of large vehicles at the corner of the road in front of the artwork

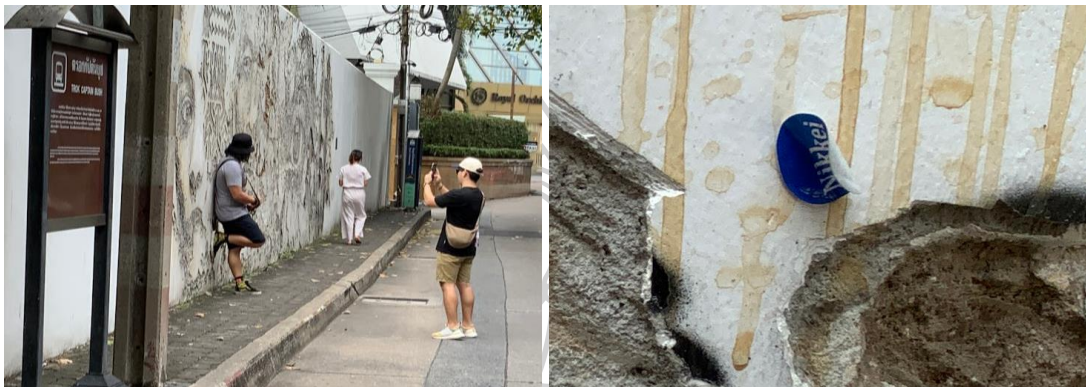
'Scratching the Surface Project' at the Portuguese Embassy wall is an important and outstanding piece of street art in the Bang Rak district that attracts tourists who regularly take pictures. It is also located near the pier, so there are always people passing by. On-site observation revealed that many people often stop by to take pictures in front of the artwork, sometimes even touching the wall directly. To pose for photographs, some people lean on it, raise one foot against the wall (figure 57), touch it by hand, put stickers on it (figure 58), or even use their hand to hit the wall while walking through, etc.

Figure 57 A man posing for photo

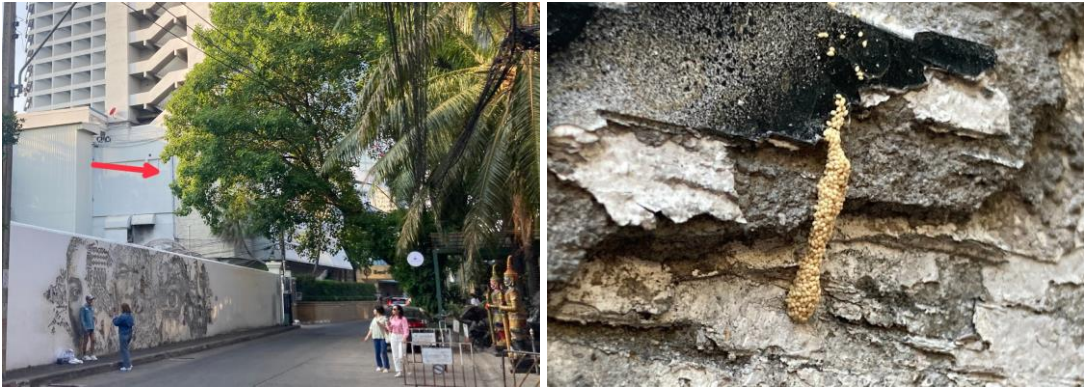
A large Bodhi tree and other trees (figure 59) in the surrounding area attract birds for shelter and to eat fruits from them. What follows is bird excrements on the wall, which causes stains. Bird droppings also contain a lot of seeds (figure 60), which, in humid climates, encourage the growth of plants in the wall's crevices (figure 61). Furthermore, the artistic technique used to reveal the surface of the wall created many gaps, which are a habitat for pests (figure 62).

Figure 59 The Bodhi tree close to the artwork
Source: Khakhanang Jonganurak (January 23, 2023)

Figure 60 Bird droppings that contain a lot of seeds
Source: Khakhanang Jonganurak (January 23, 2023)

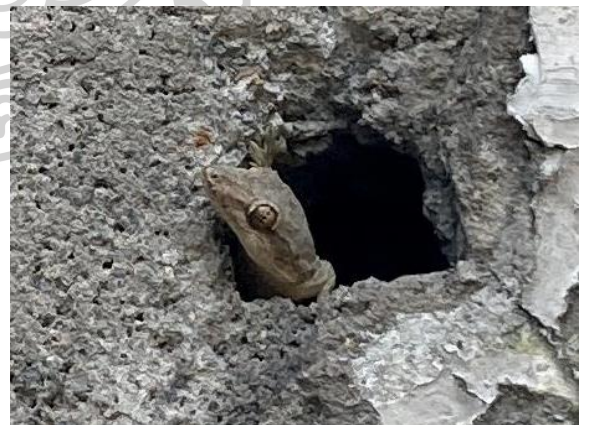
Figure 67 Gecko live inside the hollow concrete block
Source: Khakhanang Jonganurak (January 23, 2023)

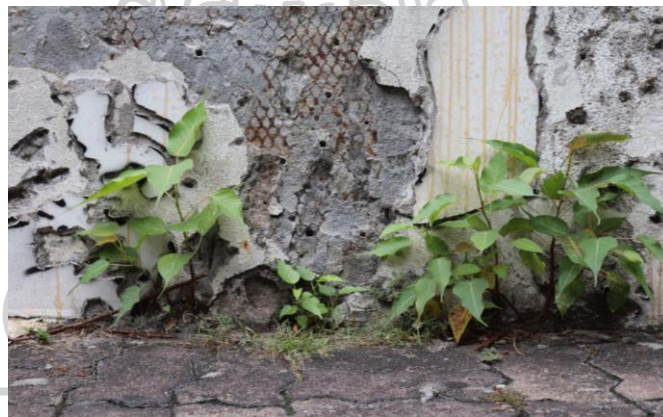
Figure 74 Plants and weeds growing in the lower areas of the wall
Source: Elias Campidell (June 12, 2023)

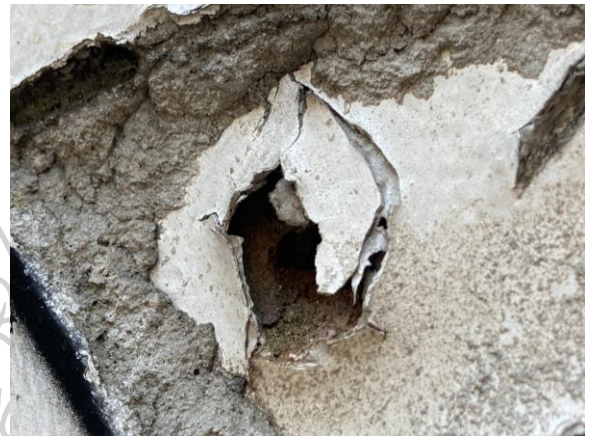
Figure 76 Peeling of paint layer on the drilling mark
Source: Khakhanang Jonganurak (January 16, 2023)

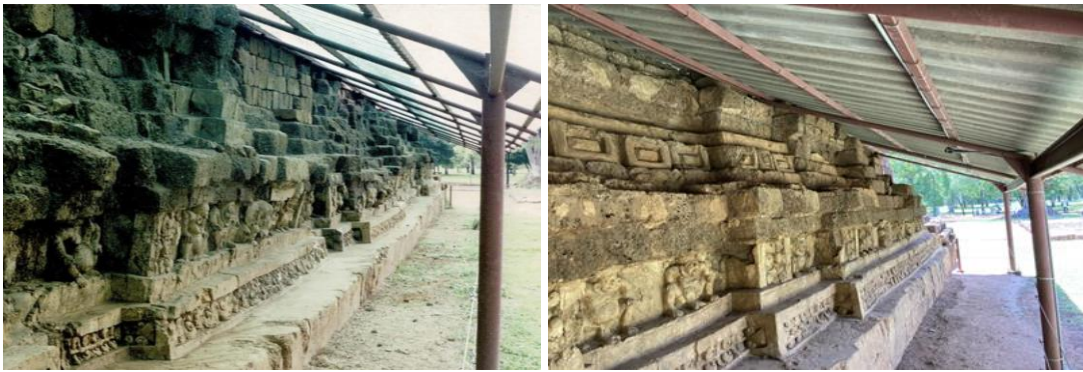
Recently, after a self-guided survey in the middle of 2022, the roof has been replaced with new, all-opaque tiles with more extended eaves (figure 83). There is also a filling of seams and roof leaks to prevent rainwater from seeping into the stucco. The shade of the roof attracts birds to live beneath it. Thus, bird droppings can be found in some areas of ancient stucco (figure 84). In addition, on the south side, where the sun shines to the bottom of the base combined with the moisture from the ground, some biological growth problems are still present (figure 85)

Figure 82 The transparent shelter for the stucco of the Khao Klang Nai

Figure 83 The galvanized shelter for the stucco of the Khao Klang Nai

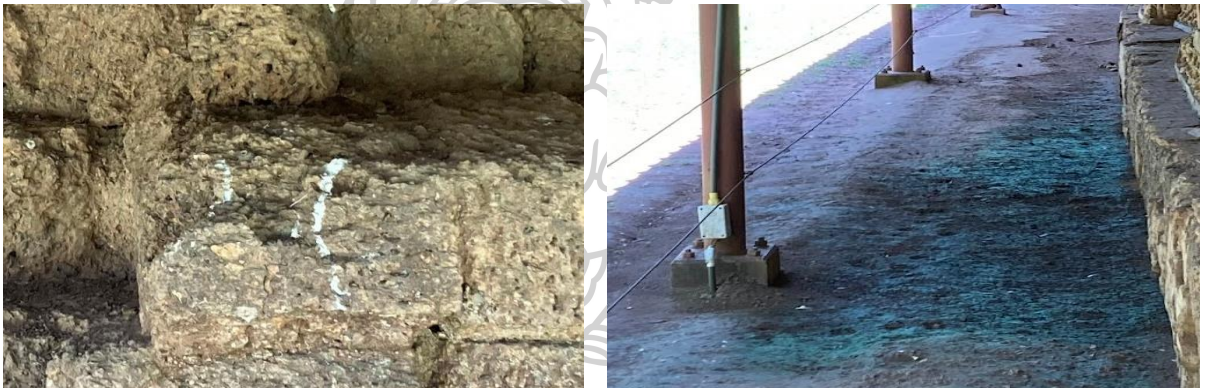
Figure 84 Bird dropping on the stucco of Khao Klang Nai

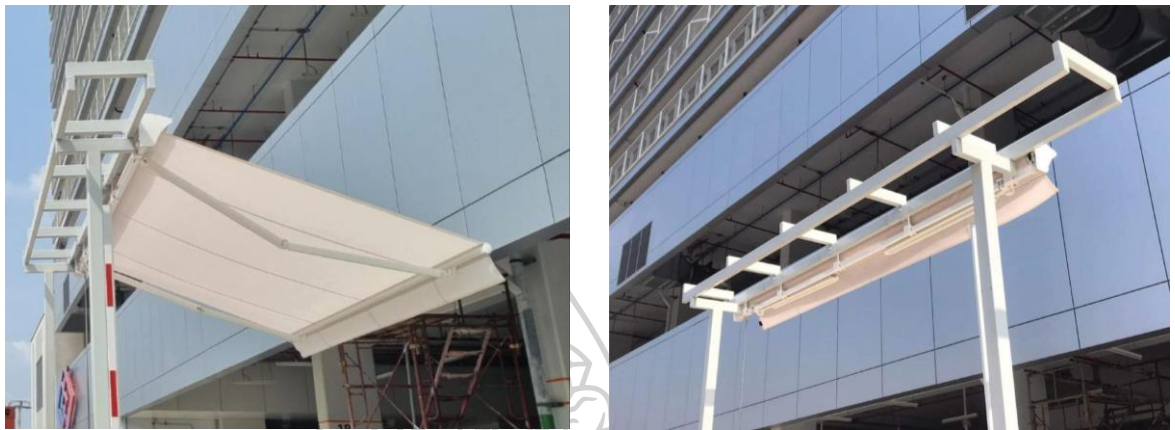
Figure 86 Movable awning shelter when it open

There are two possible ways to build a cover shelter: 1. A permanent shelter 2. An adjustable temporary shelter that can be opened and closed during the day. In terms of structure, the awning cover structure is attached directly to the wall without additional column or foundation structure to support the weight of the shelter. This method will cause the original wall to bear the entire weight of the awning cover structure. Therefore, the original construction plan should be considered first to see if the wall could carry enough weight. Without construction drawings, there is a high risk of performance assessment, which can lead to cracking and collapse due to the excessive weight of the cover extension. In addition, using mechanical tools to drill and install equipment may cause vibration that negatively affects the artwork.

The second type is an adjustable roof installation, in which a cover protection structure should be built behind the wall in the embassy's territory, as mentioned above in the permanent cover construction. The shelter cover can be retractable and only open during heavy rain or intense sunlight. During normal times when it does not rain, the umbrella of the roof can be folded down to preserve the visibility of the street art and not disturb the surrounding scenery. The cover material must be waterproof material that is flexible and opaque for retractability, such as polyacrylic, PVC-canvas, etc. Figures 86-87 is an example of a commercially available movable awning shelter. However, if it is used for work, it should be well-designed and made in the appropriate size for the artwork. Installation must consider safety and the impact on future artwork, such as problems with leakage, suitable eave distance, harmony with the context, and durable materials. In general, there are both manual and automatic systems for movable shelters, but it is recommended to use the automatic type because of the convenience of remote control. This may be done by the security officer stationed in front of the embassy's entrance. One benefit of utilizing a retractable roof is the elimination of shadows during regular hours, which helps to maintain the impact of street art on the audience. However, there are also downsides, such as the need for careful management and more complicated maintenance, which can lead to reduced durability.
